Galvanic corrosion in bolted Aluminium joints

Highrise Design has executed the initial batch of lab-testing on a series of bolted joints to determine the optimal remedy against unfavorable corrosion of aluminium structures in offshore & marine applications. This first test piece has recently endured 1.500 hrs salt spray test in the M2LAB in Udenhout, providing very clear insights.

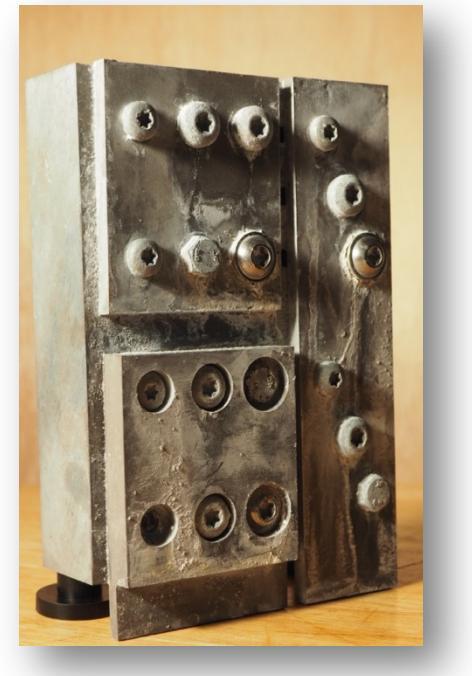
1.500 hrs

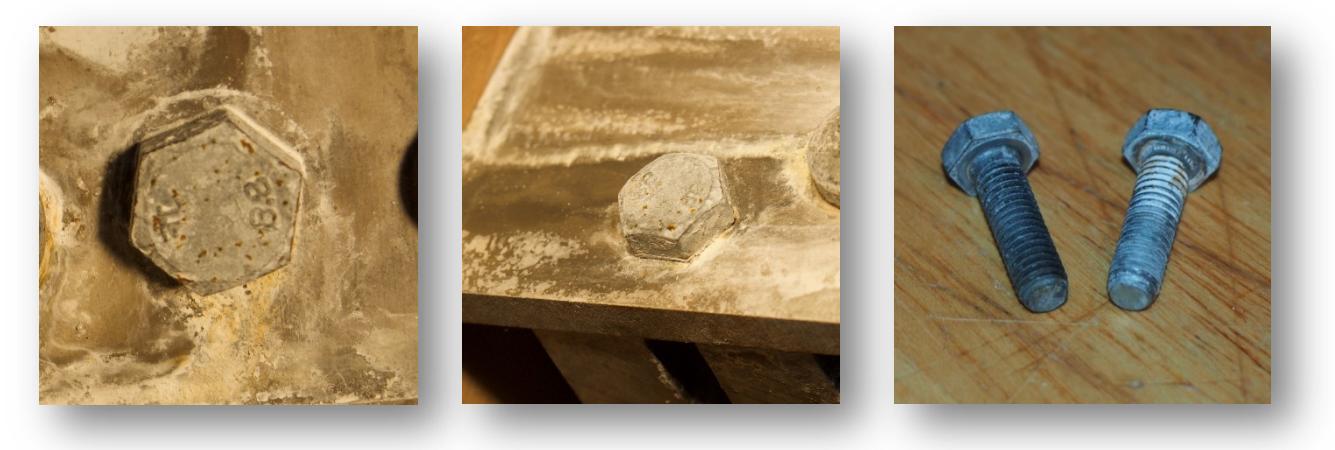
Geomet bolts

Findings: The Zn/Al coated bolts perform outstanding regarding the prevention of galvanic corrosion of the aluminium materials. After 1.500 hrs it is however visible that this coating is reaching the end-of-life stage, not being able anymore to effectively protect the carbon steel bolts from rusting. The prolonged attacks of the salt spray has used-up the Zinc-anodic reserves.

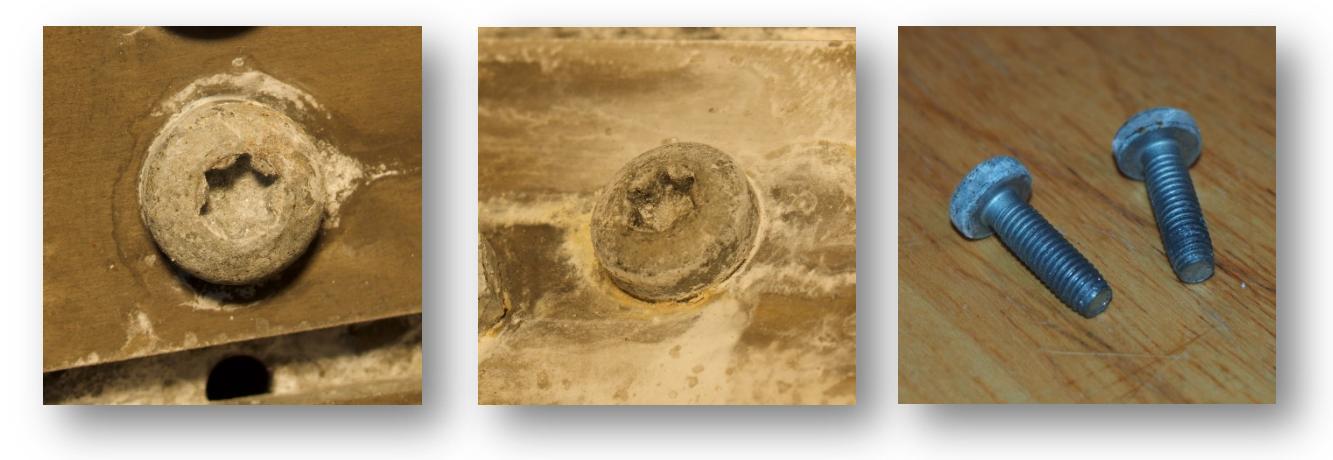
EJOT bolts

Findings: These Zn/Al coated bolts are a match to the Geomet bolts, regarding the prevention of galvanic corrosion of the aluminium materials. It would appear that the coating is slightly longer lasting. Only very minor signs of some early rust of the Carbon steel bolts is showing, certainly less pronounced than with the Geomet bolts.

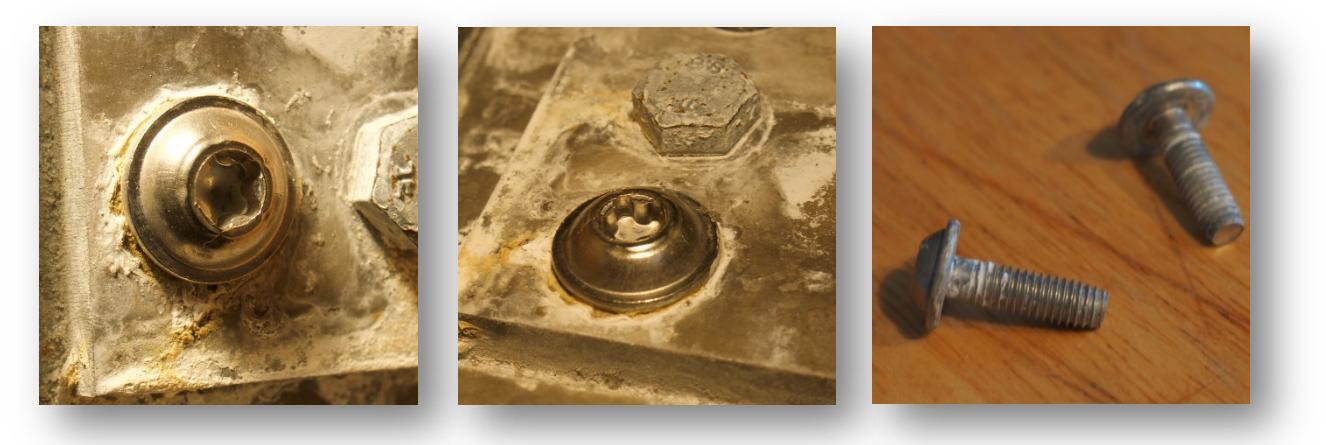
Stainless Steel bolts

Findings: The stainless steel bolts are clearly showing that the aluminium has suffered minor galvanic corrosion, resulting from contact between stainless steel and aluminium. Although the aluminium has slightly suffered, it is in no way hampering the integrity of the bolted connection after 1.500 hrs of aggressive salt spray-testing.

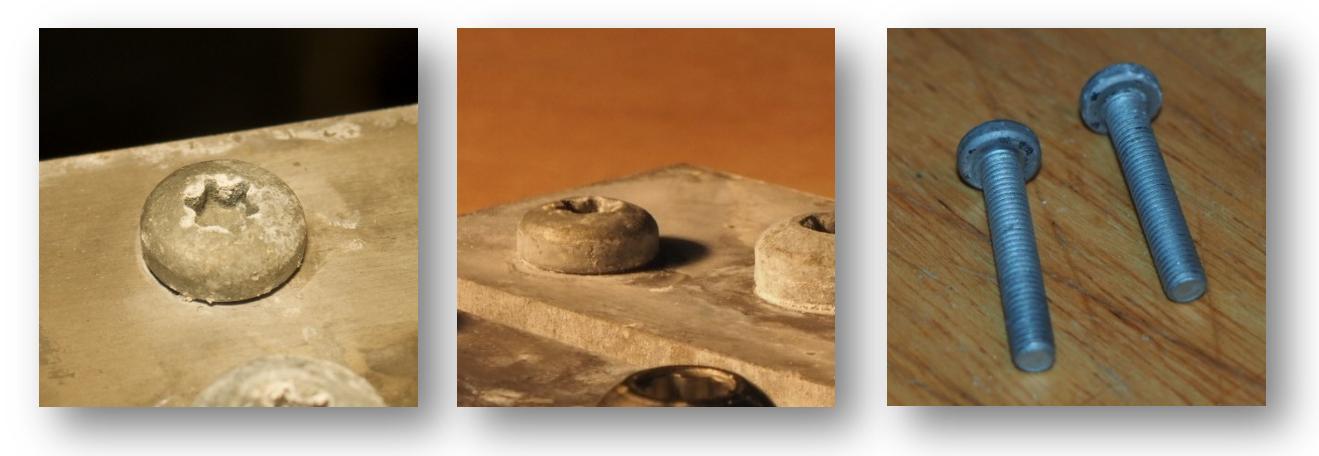
Findings: The Duplex bolts outperform the other samples by far: the aluminium remains pristine, fully unharmed. The duplex is further not showing any signs that the protective coating is reaching an end-of-life state after 1.500 hrs of testing.

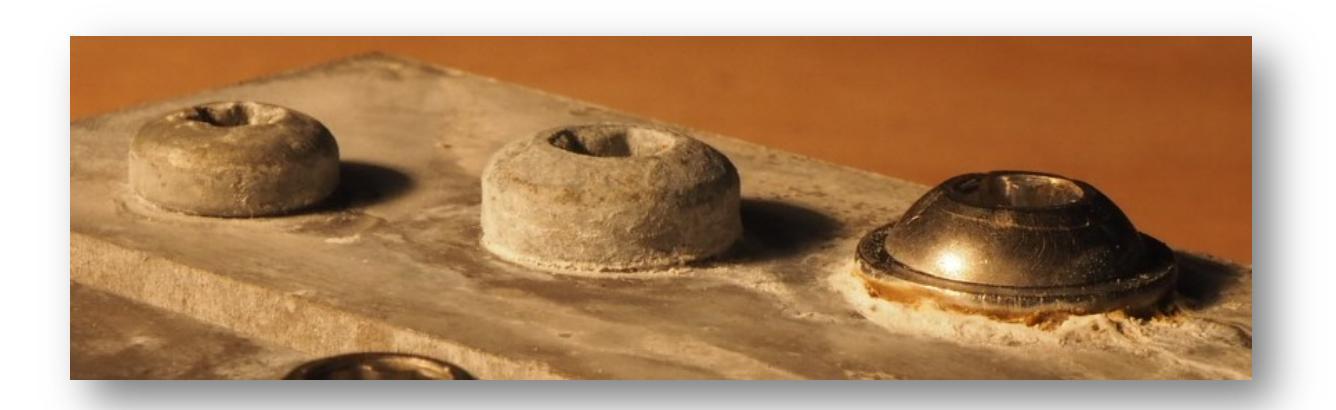
The above picture best illustrates the findings of the test:

After 1.500 hours of spray-testing, around the heads of the stainless-steel bolts (on right-hand side), clearly visible showing signs of aluminium-oxides, resulting from galvanic corrosion. The zinc/aluminium-flaked head (in the middle) shows some minor residues of zinc-oxides, but the aluminium remains unharmed. In a way more form of pollution, of the sacrificial zinc elements. At the left-hand side, the Duplex bolthead show a very pristine condition of the joint after a severe 1.500 hrs test.

Although the forming of a very limited form of galvanic corrosion around the stainless steel bolt can be considered a success, proving that the integrity of the joint is unhampered after 1.500 hrs of tested, it is clear that both the AL/Zn flaked coating and the Duplex coating perform much better in preserving the aluminium material. From these two coatings, the Duplex coating proves to a more long-lasting coating, preserving the carbon steel bolt and the aluminium for an extremely long time.
